MIPS R4400PC/SC Errata, Processor Revision 1.0

February 9, 1994

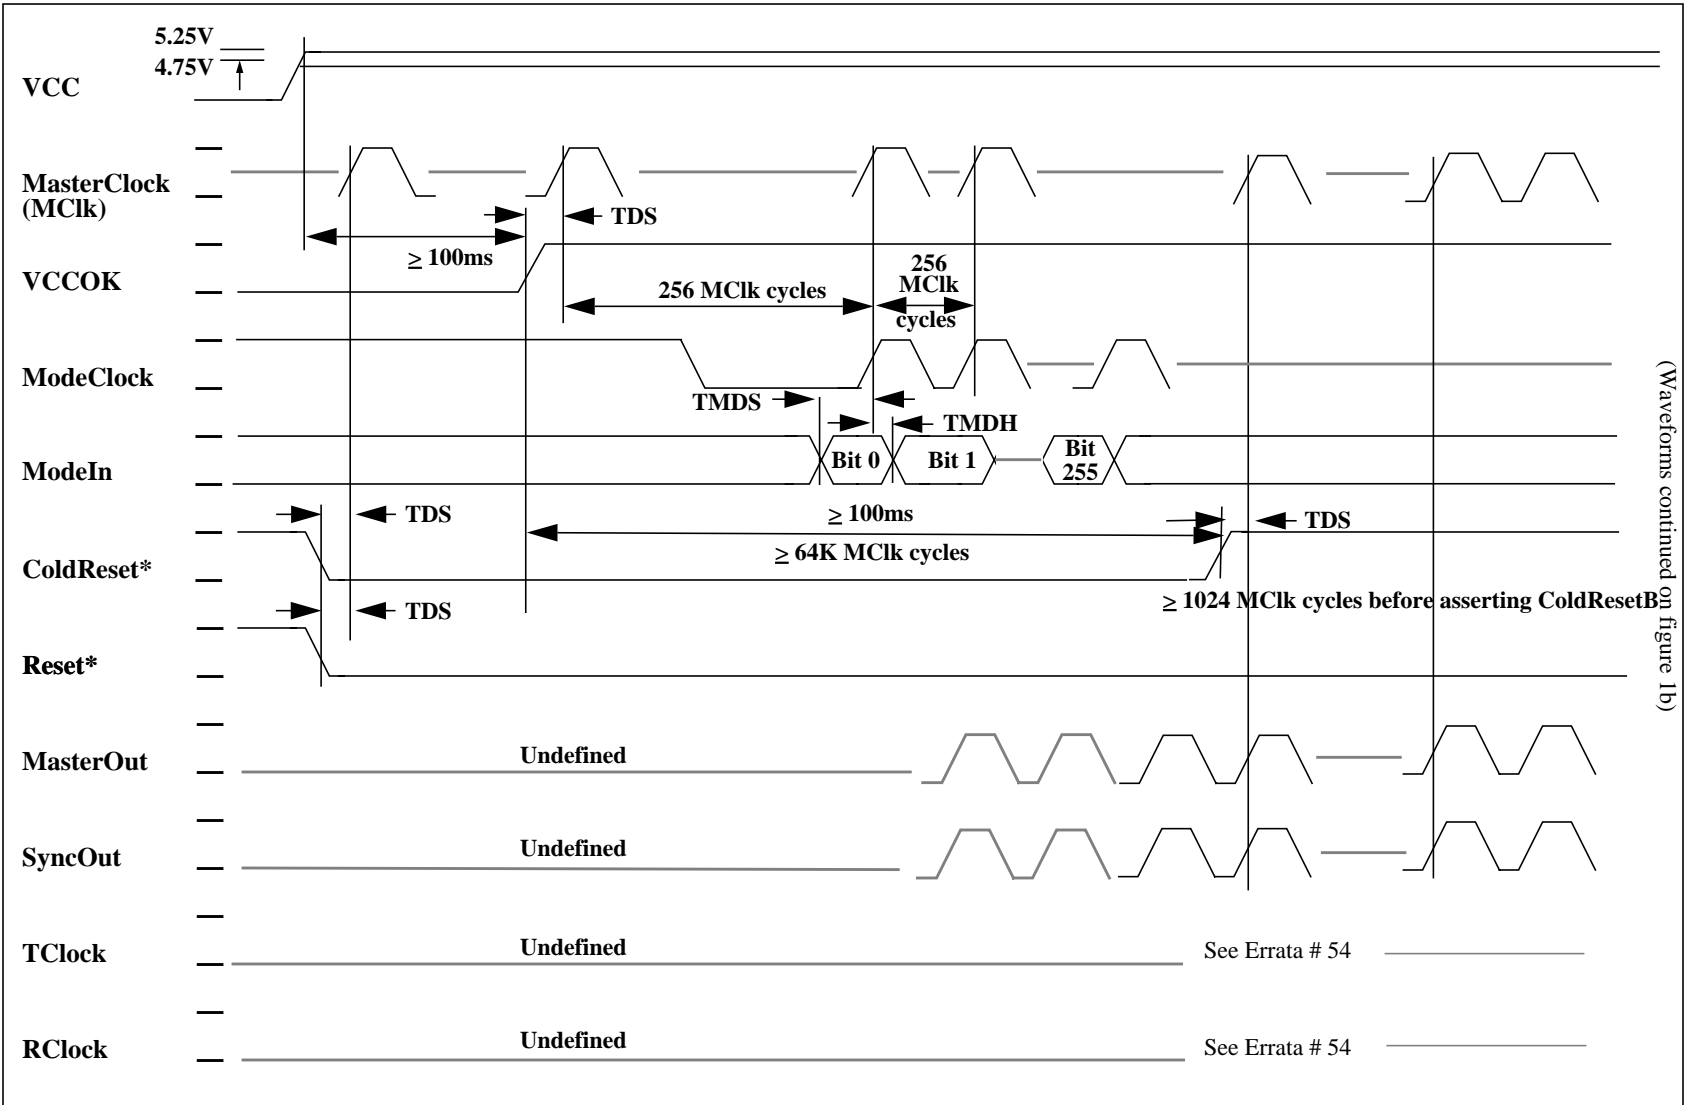
Figure 1a: Power-on Reset or Cold Reset - Workaround for Bug# 22

- 22. R4400PC, R4400SC: During the power up sequence, the period of TClk and RClk may not be as expected for at least 1024 MasterClock cycles following the de-assertion of ColdResetB. The above bug is true for all system interface divisors. Furthermore, if the system interface divisor other than 2 (i.e. 3,4,6 & 8) is used, TClk and RClk's rising edge may not align to the rising edge of the MasterClock, as specified.

Workaround: Assert a second ColdResetB after at least 1024 MasterClock cycles from the de-assertion of the first ColdResetB. ResetB should remain asserted until at least 64 MasterClock cycles following the de-assertion of the second ColdResetB. TClk and RClk will then be valid 64 MasterClock cycles after the de-assertion of the second ColdResetB and their edge alignment with respect to MasterClock will be as specified. Figure 1a & 1b show the waveforms in more detail. Note that the waveforms in Figure 1b are continuation of the those in figure 1a.
